IAS Uses High Velocity Oil Flushing Service to Clean Lube Oil and Hydraulic Systems Prior to Commissioning

During the commissioning of an Aero Derivative gas turbine, field fabrication resulted in the introduction of metal debris, airborne dirt and dust into the new tubing and piping of the oil system. In addition, contaminants introduced during the manufacturing process ingressed many of the same type contaminants also known to cause premature wear and in some cases premature component failure.

Based on previous experience with like systems under similar conditions, IAS will perform a High Velocity Oil Flush to remove all solid contamination from the lube and hydraulic oil supply and return lines of the gas turbine. IAS also will purify the final fill turbine oil to OEM and owner specifications.

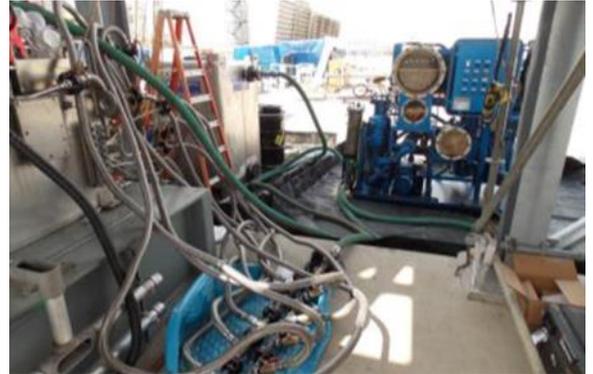
Process Equipment Set Up

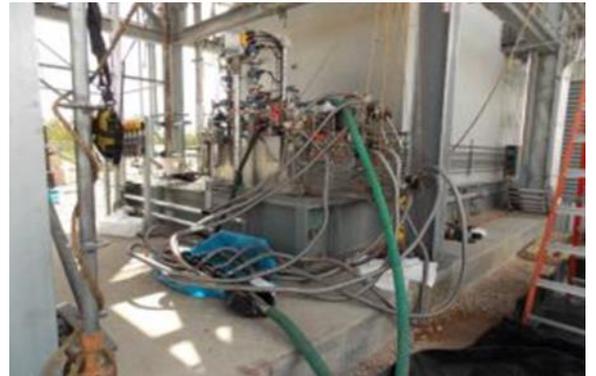
Jumper Location

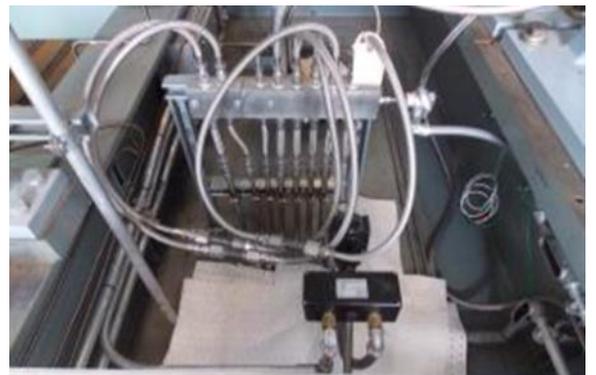
Jumper Location

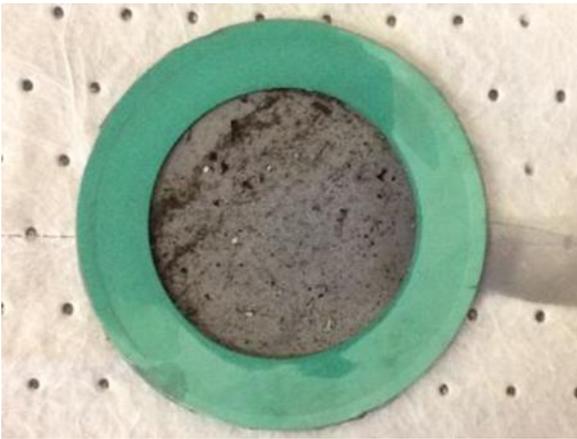
Initial Return Line Screen, April 7

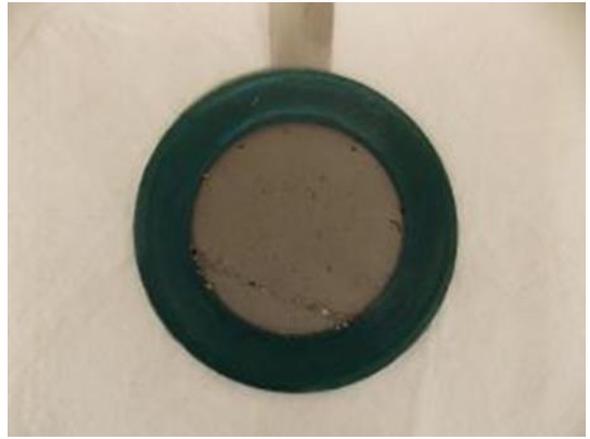
Second Return Line Screen, April 8

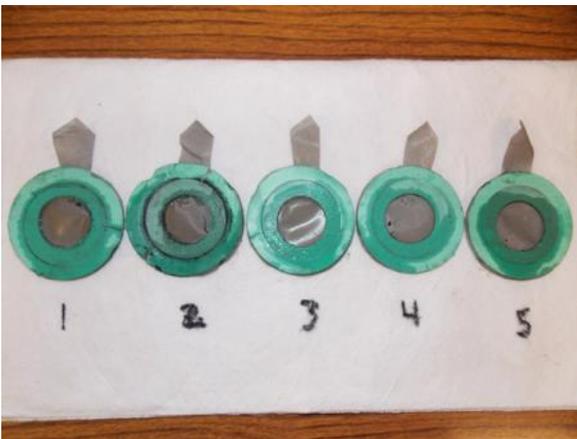
Manifold Screens, April 9

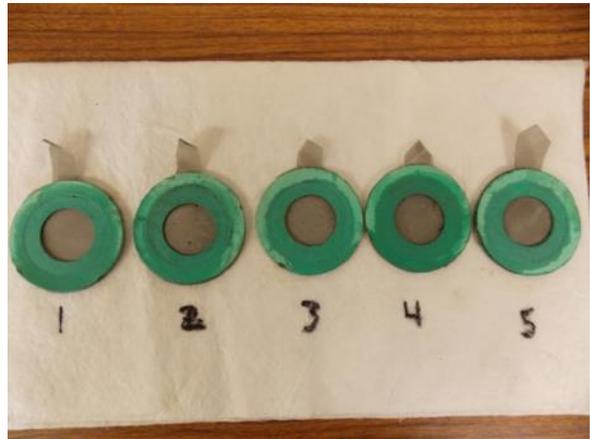
Manifold Screens, April 10

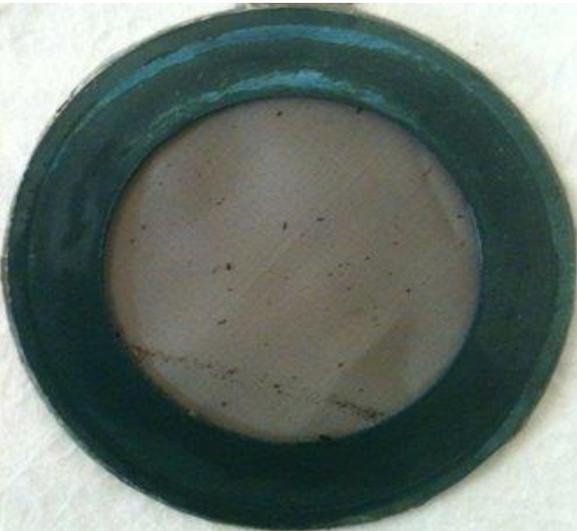
Third Return Line Screen, April 10

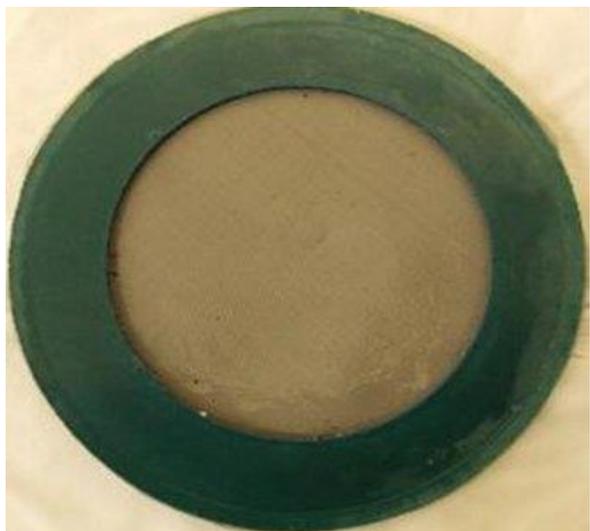
Final Return Line Screen, April 11

The final screen and target ISO Cleanliness Code was approved on April 11, 2013. The customer was satisfied with the results and called the flush completed. IAS began reinstating the system supply and return lines and began demobilization.

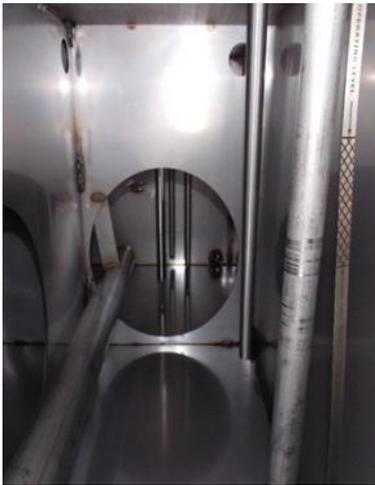
Before

Even though the reservoir was previously cleaned at the factory, the customer requested IAS inspect and remove any remaining contamination. Only a very small amount of oil and soft contamination were found and removed by IAS.
